INVESTIGATING CARRY BACK

Richard Shields
and Daniel Marshall,
Martin Engineering, US,
chart an investigation into
conveyor belt cleaning practices
at a Powder River Basin coal mine.

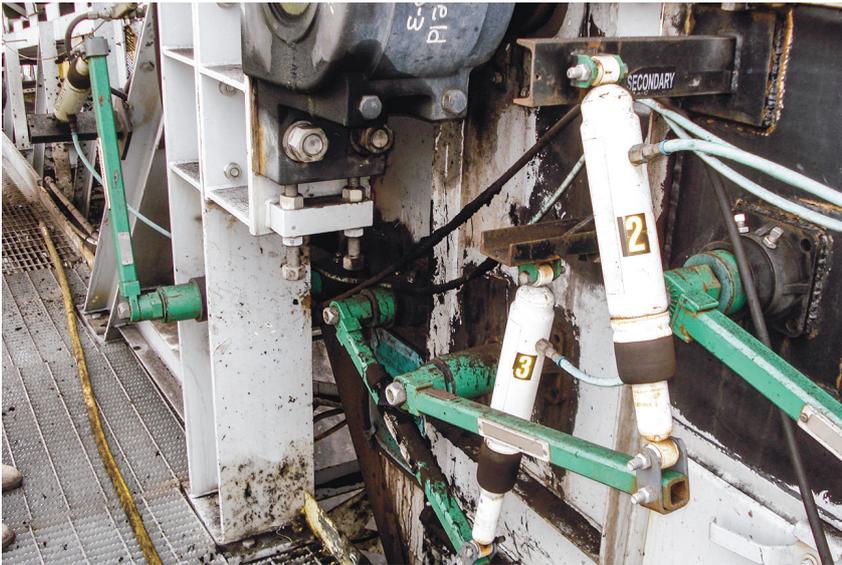
Company management questioned the purchase price and replacement blade costs for the existing system, as well as the overall cleaning effectiveness.

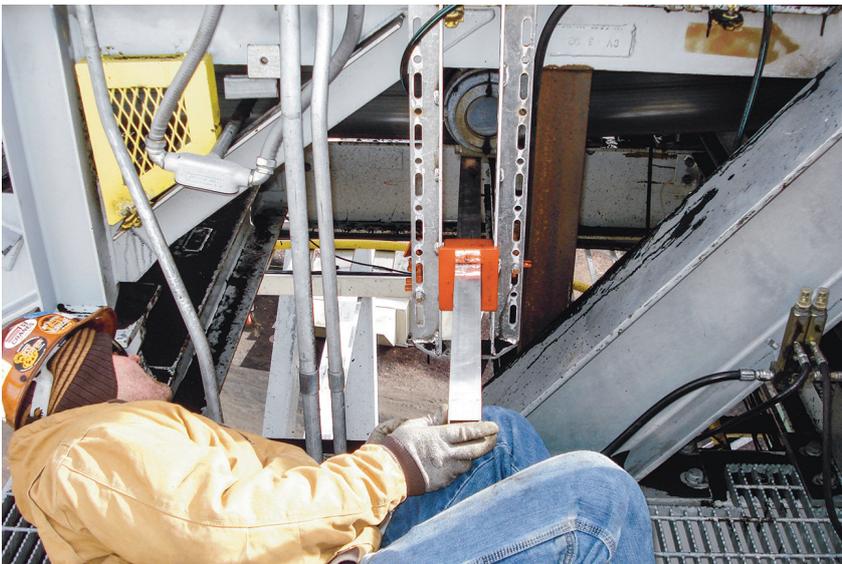
The Martin Conveyor Belt Carryback Gauge is a patented tool designed for estimating the amount of carryback on the return side of a conveyor belt.

The methodology used for measuring the amount of carryback was the Martin Conveyor Belt Carryback Gauge (Model 38840), a patented tool designed for estimating the amount of carryback on the return side of a conveyor belt. The gauge places a blade against the belt, removing carryback and depositing it in a collection cup. Representative 60 sec samples of carryback are taken at three locations across the belt surface, one on each side located a third of the distance from each edge of the belt, as well as one in the exact middle. In an effort to obtain statistically meaningful test results, each individual test required three samples.

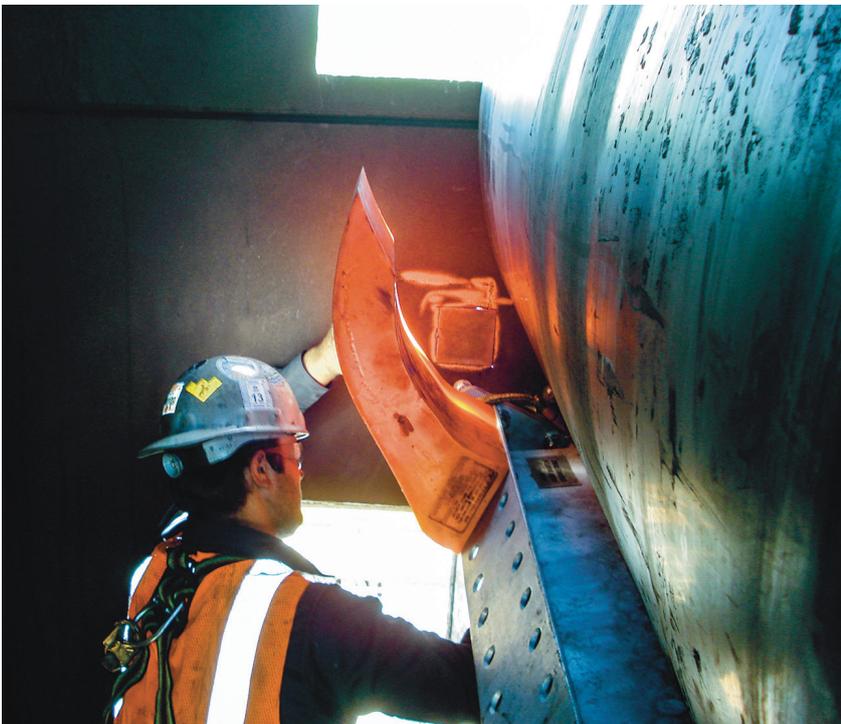
A Martin technician installs the new cleaning system, which used just two blades per belt instead of four.
